**UNION RESERVOIR
WELD COUNTY, COLORADO**

NATURAL RESOURCES AND HABITAT ASSESSMENT UPDATE

REVIEW OF MASTER PLAN ACTIONS AND RECOMMENDATIONS

May 17, 2011

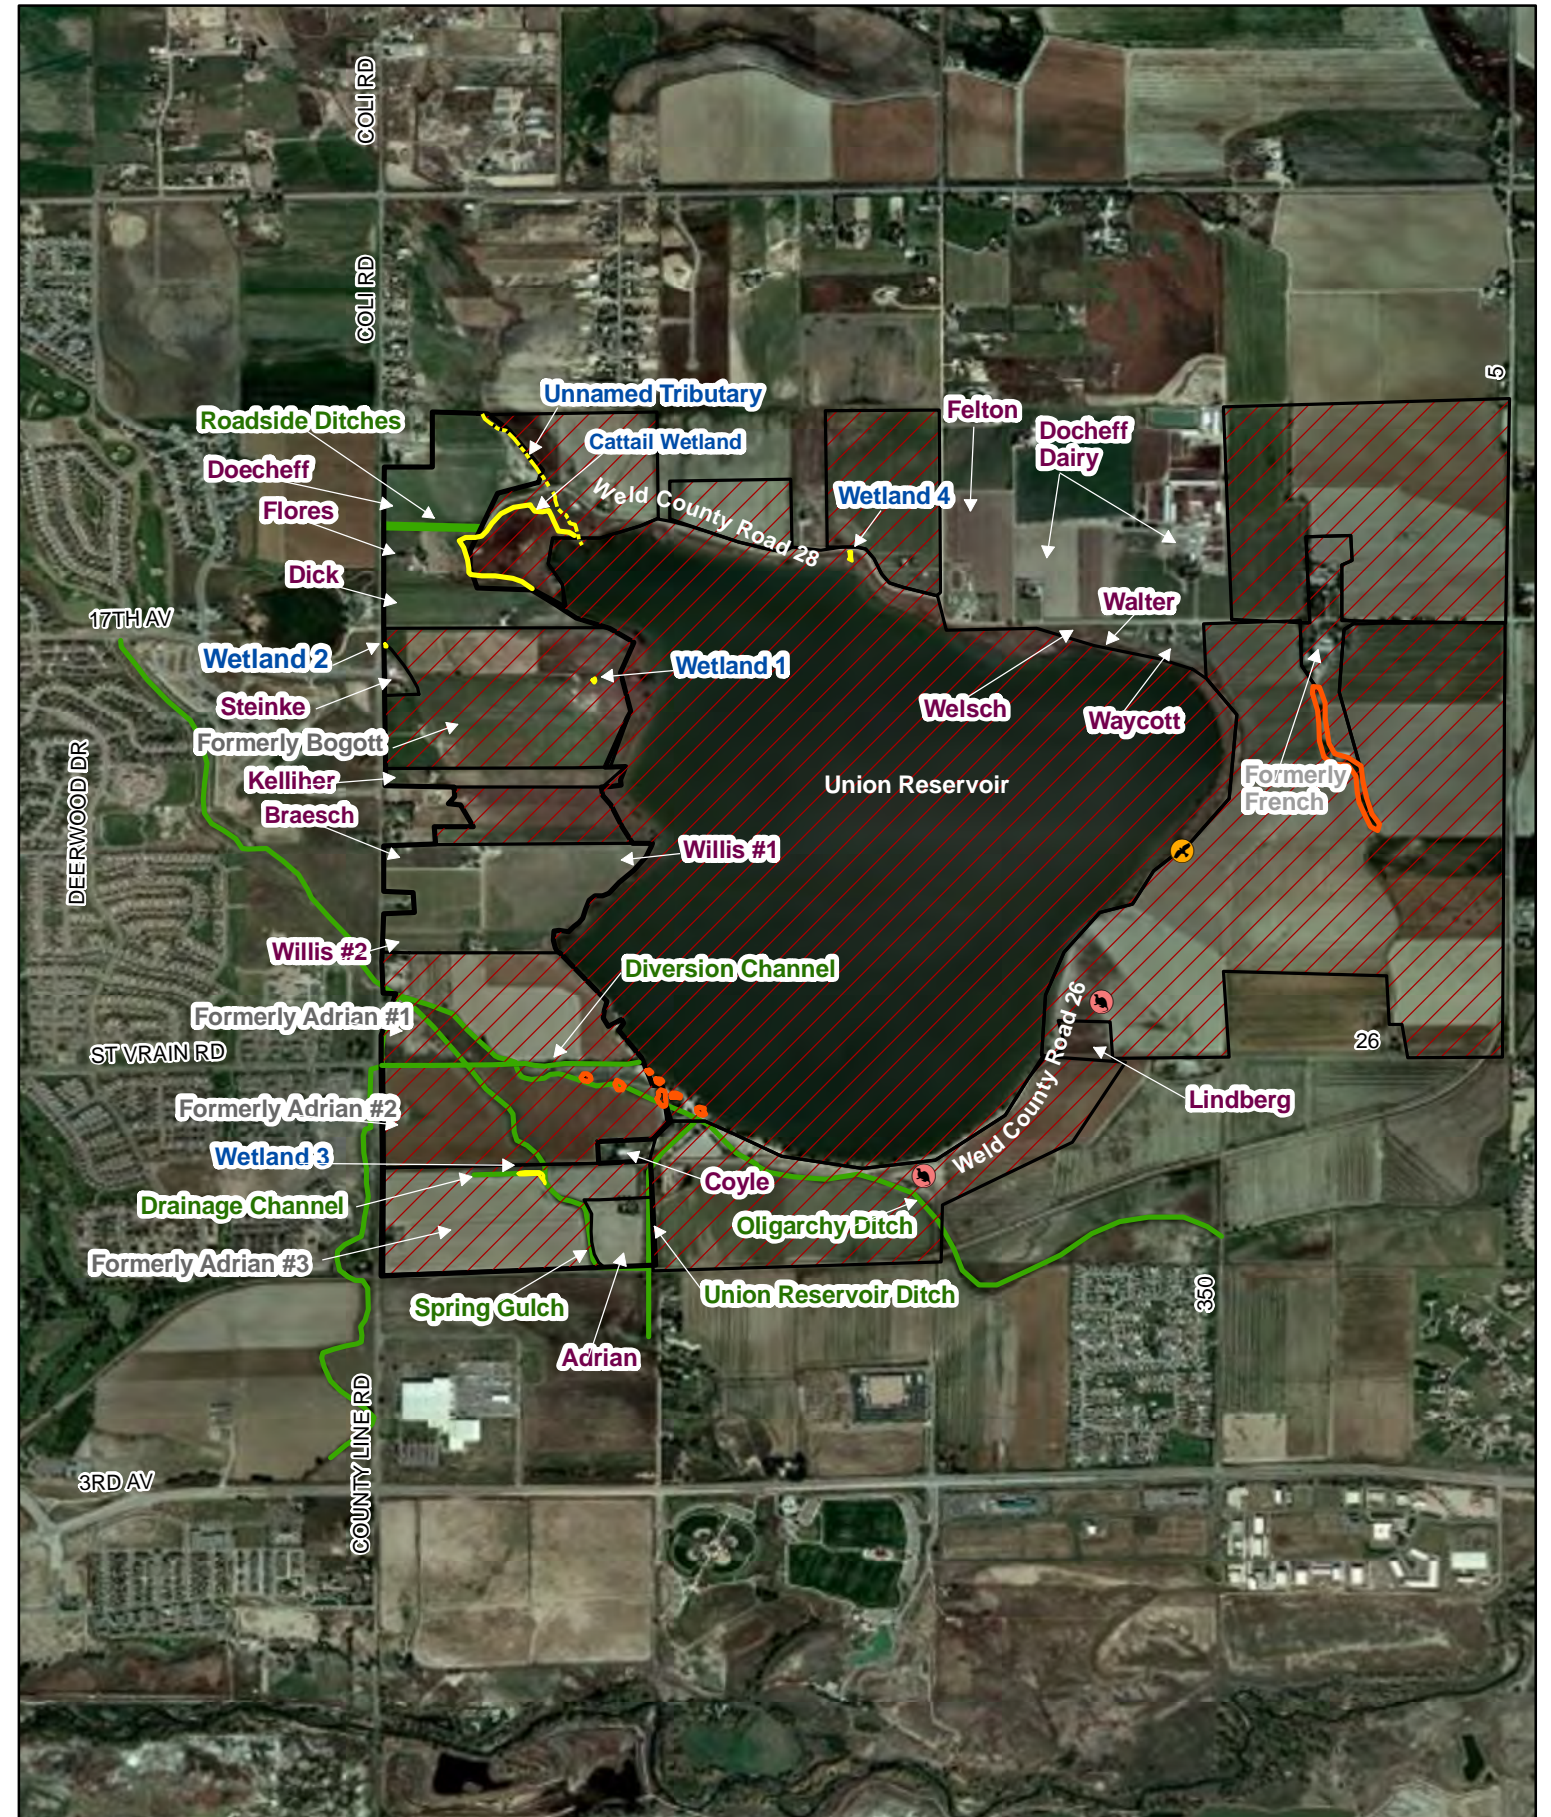
Figure 2. Natural Resources and Habitat Features

ERO identified 16 parcels based on the last name of the property owner (Figure 2). These lands are either privately-owned, controlled by or owned by the City of Longmont (City). The parcels comprise rural residential homes, agricultural production, commercial nurseries, and recreational facilities associated with Union Reservoir (ERO, 2006a). Land use under private ownership is mainly historic or active agricultural production including livestock grazing, hay production, land cultivation, and associated ditches. ERO noted and delineated native wetland vegetation occurred between the reservoir high and low waterlines, dominated by cattails (*Typha latifolia*) and sandbar willows (*Salix exigua*).

A stand of mature cottonwood trees on City land (formerly Adrian parcel #2) on the western side of the Reservoir was identified by ERO in 2006 (Figure 2). It has been verified by Colorado Division of Wildlife (CDOW) that bald eagles were not using these trees for a nighttime roost at the reservoir (CDOW 2008a). Additional surveys by Union Reservoir rangers concurrent with CDOW surveys documented foraging activities but not roosting behavior.

Spring Gulch flows from northwest to southeast across the southern portion of the Union Reservoir area. (Figure 2) and appears on the U.S. Geological Survey (USGS) topographic map as an intermittent tributary to Saint Vrain Creek.

The eastern shoreline is mainly City-owned, with the exception of the Lindberg parcel (Figure 2). A black-tailed prairie dog colony near the east perimeter and sail club area appears to occur on both City land as well as the Lindberg parcel. The prairie dogs are concentrated in the western portion of this space but appear to be expanding eastward where the land is tilled and looks to be in active agriculture (Photo 8).

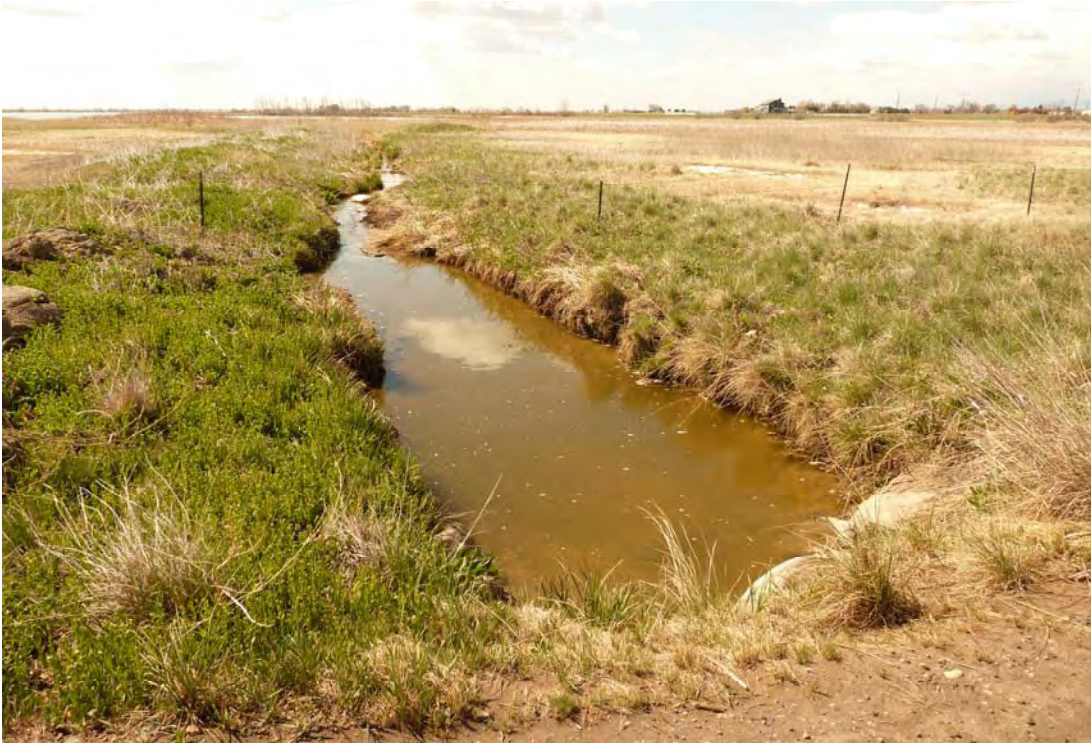
In 2006, emory sedge (*Carex emoryi*), saltgrass (*Distichlis spicata*), rabbitfoot grass (*Polypogon monspeliensis*), and curly dock (*Rumex crispus*) were observed along the tributary (ERO 2006a). The same wetland conditions and vegetation were observed in 2011 (Photo 1).

Because this tributary has wetland vegetation, a defined channel bed and bank, and a surface flow and connection to waters of the U.S., it is likely under jurisdiction of USACE.

Photo 1. May 2, 2011. Looking south at Unnamed Tributary from Weld County Road 28.

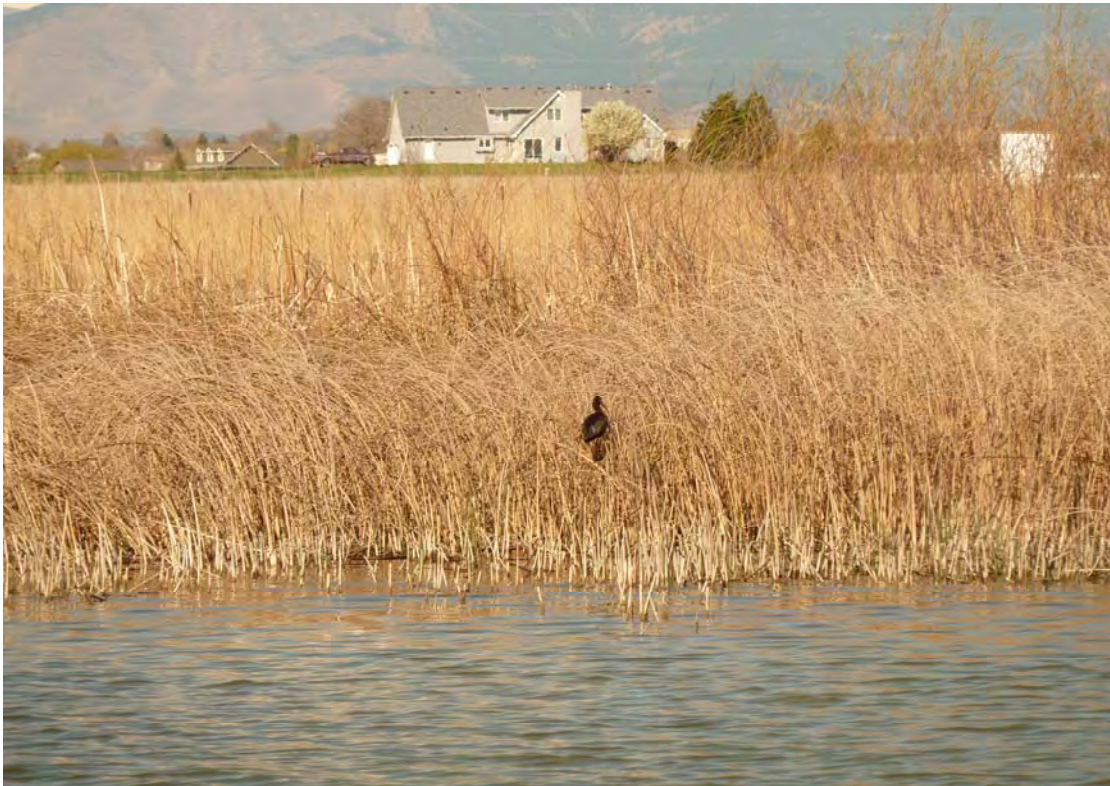
Wetland vegetation between the low and high water marks along the western edge of Union Reservoir consists of cattails, three-square (*Schoenoplectus pungens*), and sandbar willows (Photo 2). In the large cattail-dominated wetland marsh in the northwestern portion of the reservoir, species observed included Baltic rush (*Juncus balticus*), spike rush (*Eleocharis* sp.), and three-square (ERO 2006a). In 2011, bulrushes (*Schenoplectus* spp.) were also observed in this area (Photo 2).

Because Union Reservoir has a surface connection to Saint Vrain Creek via the Union Reservoir Ditch, the reservoir and associated wetlands would likely be under the jurisdiction of USACE.

Photo 2. May 2, 2011. Looking west, northwest at wetland marsh vegetation between the high and low water marks of Union Reservoir. Roosting white-faced ibis (*Plegadis chihi*) in foreground.

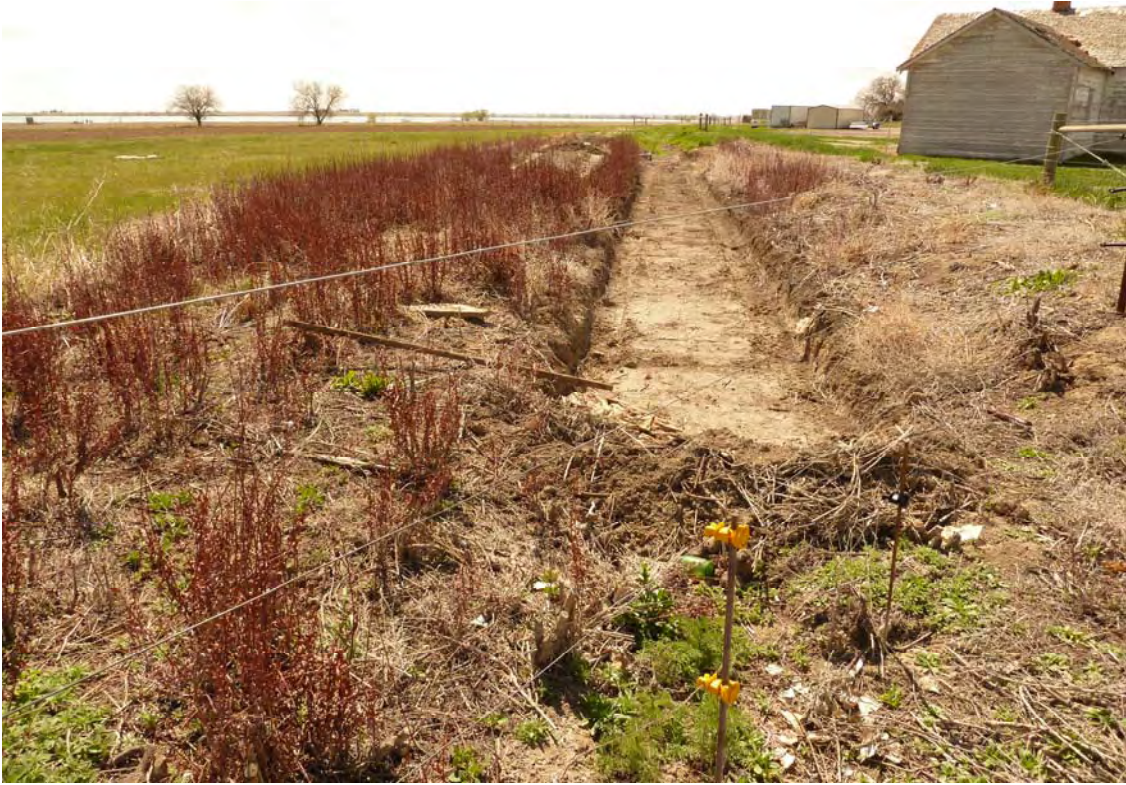
Wetland 2 occurs in the northwestern portion of on the Steinke parcel and is associated with a shallow, actively-managed irrigation ditch with surface connection to Union Reservoir. The extent of wetland vegetation appears to have contracted since 2006. Sandbar willow stems in the ditch channel have been cut. The ditch was dry in 2011 with stands of saltgrass and dead sandbar willow shoots along the edges (Photo 3). This ditch may no longer be used to flood irrigate the former Bogott property now that the City owns this parcel.

Photo 3. May 2, 2011. Looking south at Wetland 2.

Walsh concurs with ERO (ERO 2006a) in the recommendation that USACE be requested to conduct a jurisdictional determination of these geographically isolated waters and wetlands, should the area be potentially impacted by future development decisions. In addition, a presence/absence survey for Ute ladies'-tresses should be conducted.

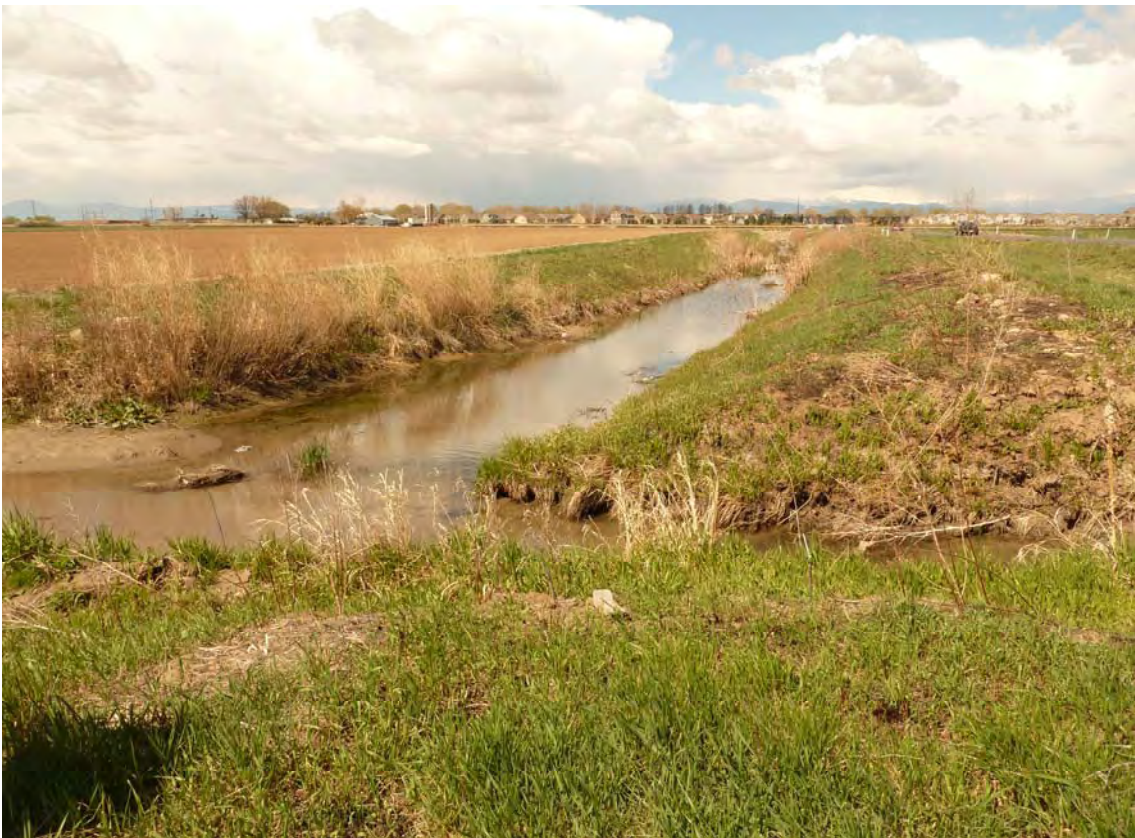
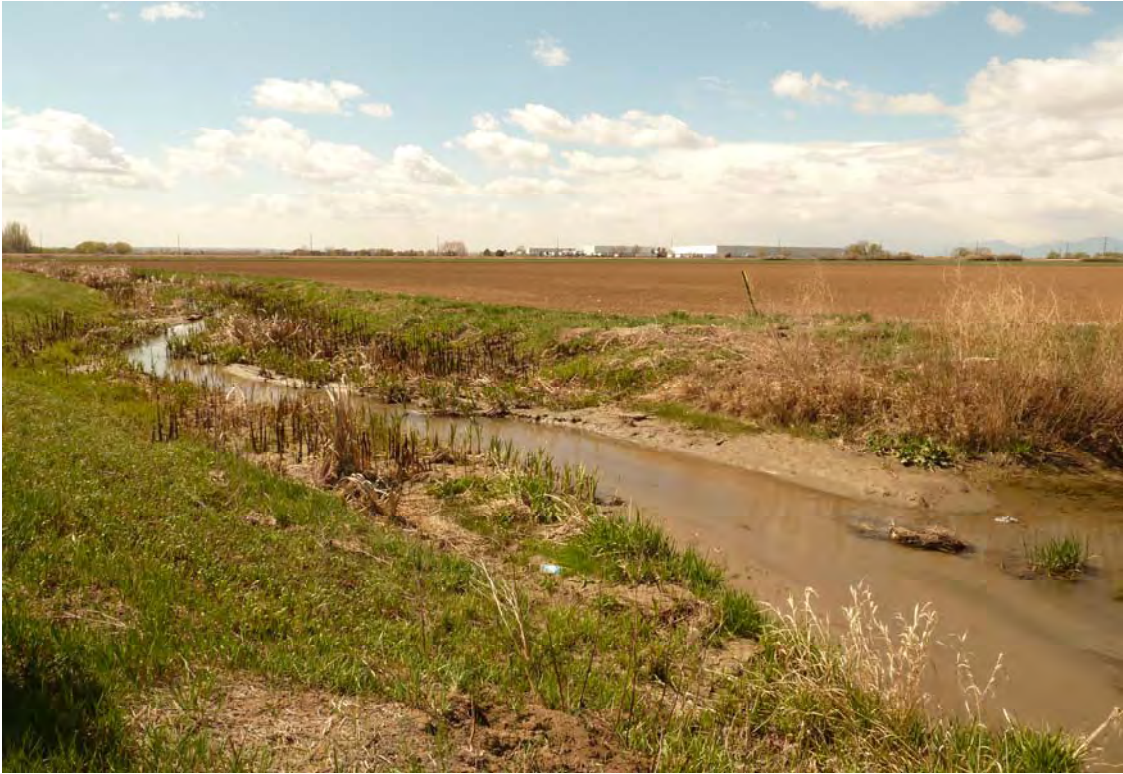
In 2006, vegetation in the channel included cattails, softstem bulrush (*Schoenoplectus lacustris* subsp. *acutus*), American speedwell (*Veronica americana*), and three-square. In 2011, the area was observed to have been burned. The extent of this cattail-dominated wetland has changed from an east-west linear extent to a L-shape with branches extending west as well as south. Wetland 3 no longer extends as far toward the west (Photos 4 and 5).

Because the drainage channel has wetland vegetation, a surface flow, and connections to St. Vrain Creek via Spring Gulch and Union Reservoir Ditch, it would likely be under USACE jurisdiction (ERO 2006a).

Photo 4. May 2, 2011. Wetland 3, looking west.

Photo 5. May 2, 2011. Wetland 3, looking south to the area of wetland vegetation that has expanded to the south since 2006.

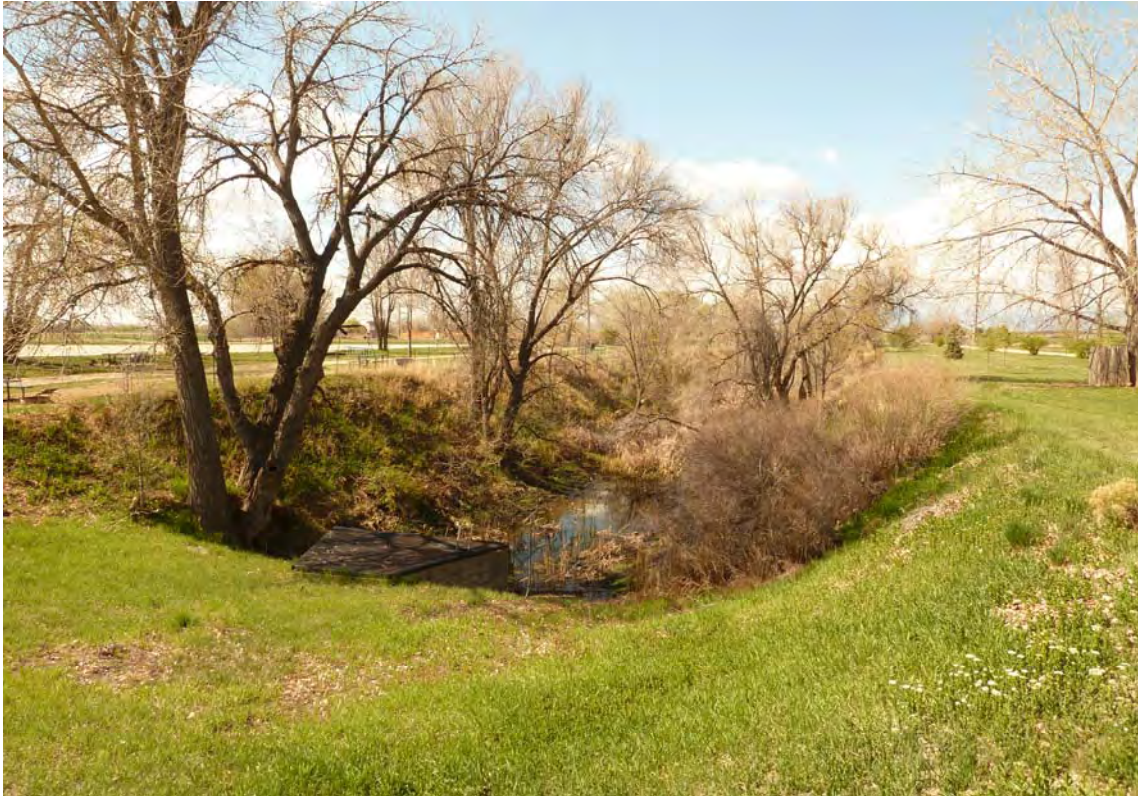
Union Reservoir Ditch flows south from Union Reservoir adjacent to the southeastern edge of the previous habitat assessment boundary. In 2011, whitetop or hoary cress (*Cardaria draba*) was observed growing on the upper slopes near the metal outlet structure at the northeast portion of Union Reservoir Ditch (Photo 6). Whitetop is listed for control on the Colorado Noxious Weed List B (CDA 2011) and the Weld County Control Weed Species- List B (Weld County 2011).

Photo 6. May 2, 2011. Looking at the metal outlet structure at the northeast portion of Union Reservoir Ditch where water from Union Reservoir comes into the Ditch. Whiteop (*Cardaria draba*) was observed on the upper banks of this area.

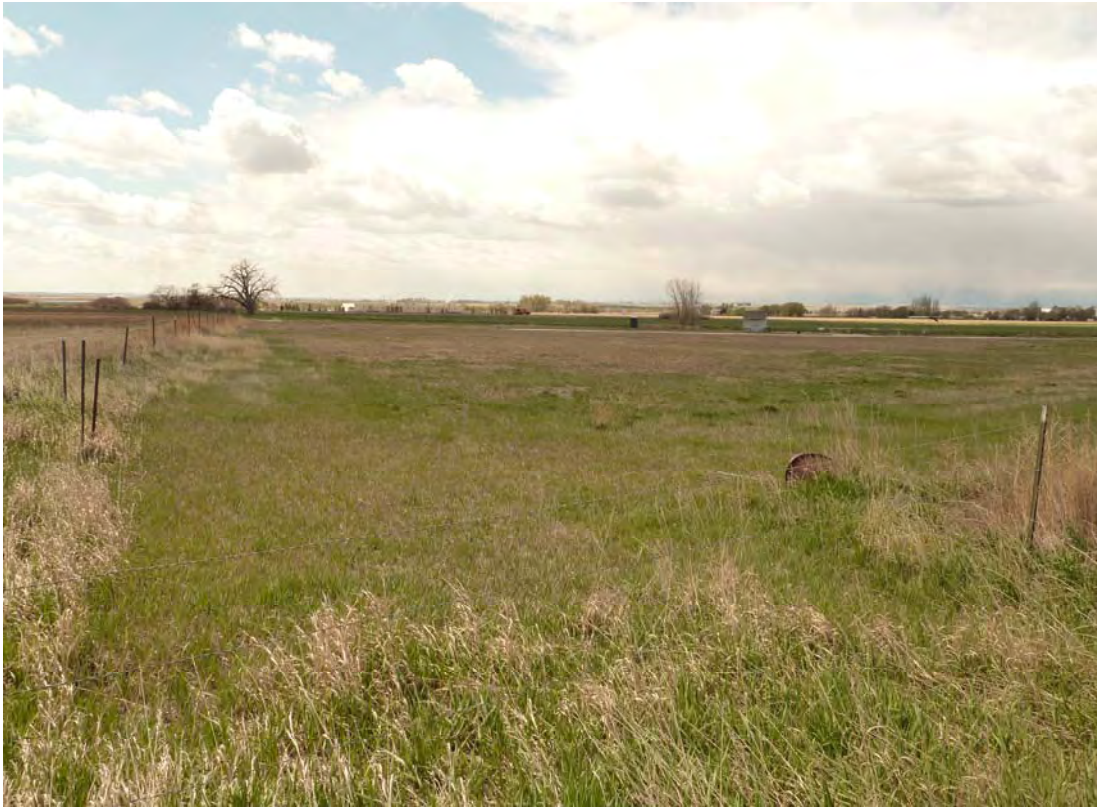
A prairie dog colony occurs on City property near the south perimeter of the reservoir site (Photo 7). During a single burrowing owl call survey conducted on April 26, 2011 in accordance with protocol recommended by CDOW (CDOW 2008), Walsh did not detect burrowing owls in the active prairie dog colony.

Photo 7. May 2, 2011. Looking south at an active prairie dog colony south of the Reservoir. This old agricultural field is a City parcel. No burrowing owls were detected here in April, 2011.

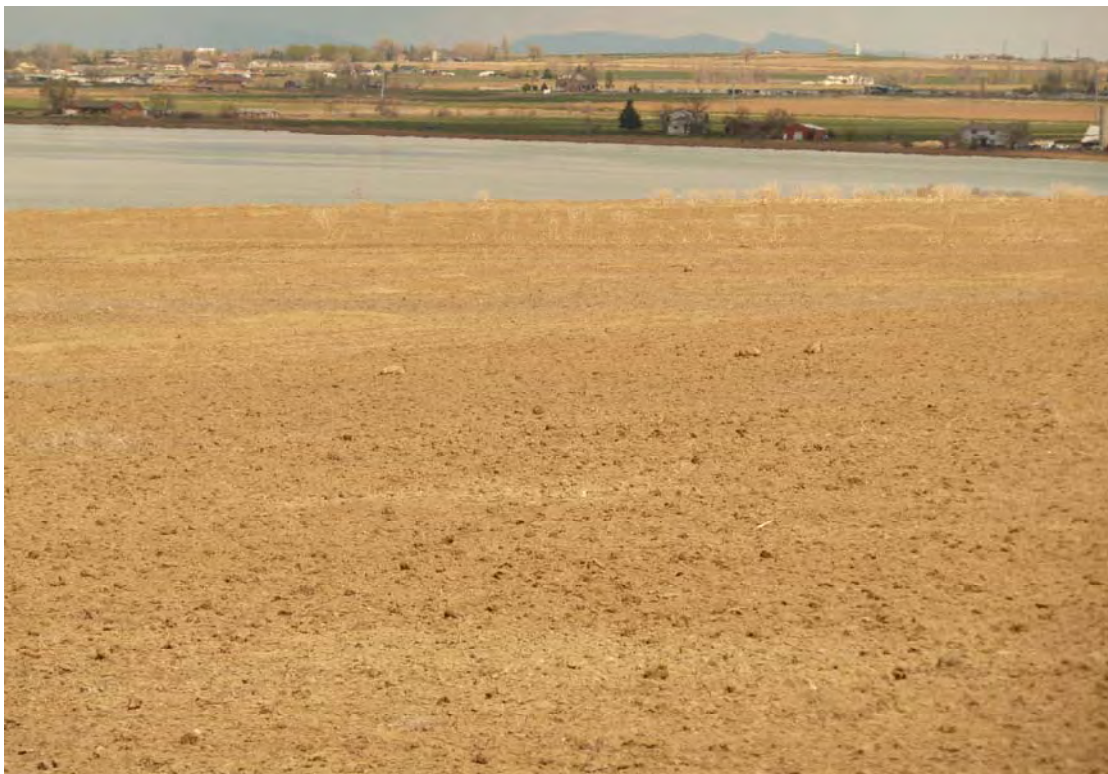
Photo 8. May 2, 2011. Looking west at the active prairie dog colony southeast of the Reservoir. This barren agricultural field and prairie dog colony appear to be on both City-owned land and the Lindberg parcel. No burrowing owls were detected here in April, 2011.

- The black-tailed prairie dog colony east of the sail club area is already extending east and appears to be affecting both City and private parcels. The ‘draft revised east area’ of the master plan update could further encroach on this prairie dog colony. Consider developing a colony and site specific management plan for these prairie dogs using the categories laid out on pages 40 through 43 of Longmont’s Wildlife Management Plan (Walsh 2005), e.g., preserve, actively manage/replace, actively manage/exclude, remove/relocate, remove/euthanize, exterminate.

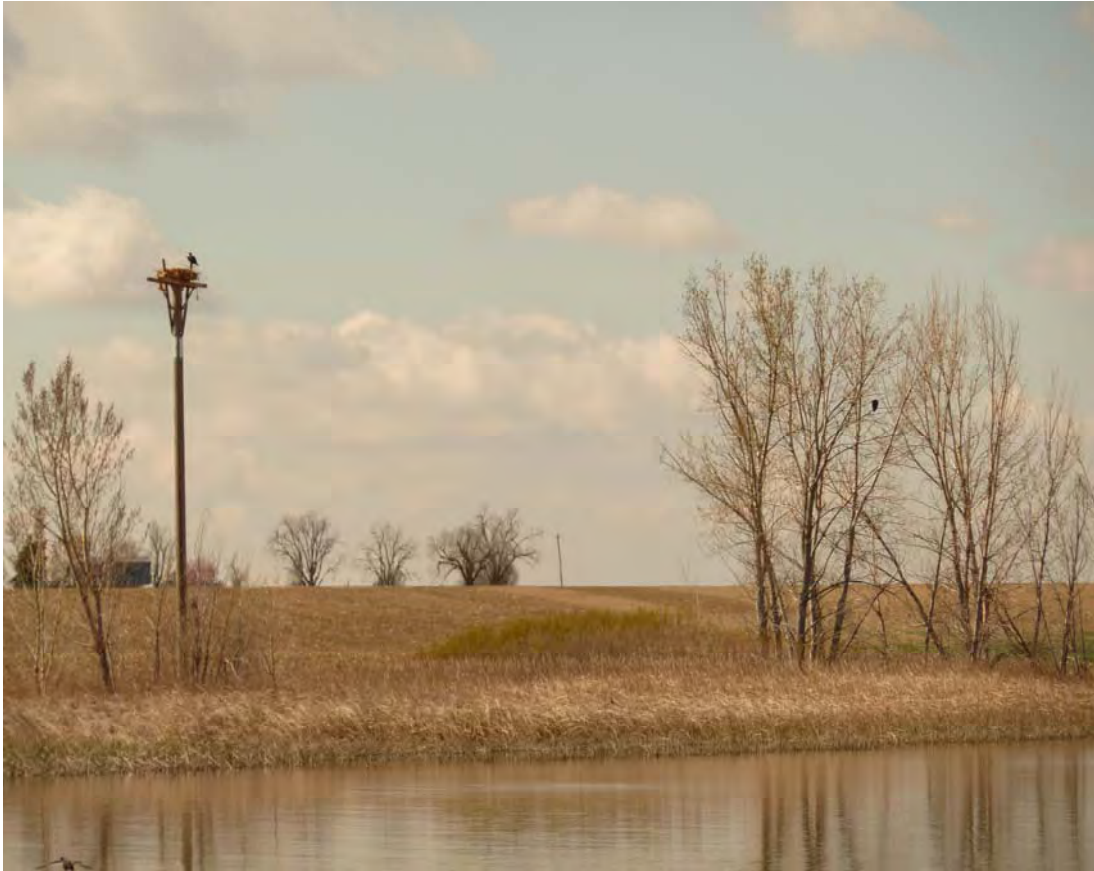
Near a constructed osprey (*Pandion haliaetus*) platform, the eastern shoreline supports a band of wetland vegetation dominated by cattails. In May 2011, a nesting pair of ospreys was utilizing the platform and nearby willow trees (Photo 9).

Photo 9. May 2, 2011. Looking southeast at a pair of ospreys utilizing the platform and what appear to be willow trees along the east Reservoir shoreline. The shoreline looks like it is dominated by cattails, bulrushes, and willows.

- An osprey platform with an active nest was noted by Walsh biologists at approximately N40.181630°, W105.028418. To remain compliant with the MBTA, CDOW recommends “no surface occupancy (beyond that which historically occurred in the area) within ¼ mile radius of active nests” and a “seasonal restriction to human encroachment within ¼ mile radius of active nests from April 1 through August 31.”

There are several options available for sections of the loop trail that fall within ¼ mile of the osprey platform. First, the trail could remain where it is but these sections should be marked for seasonal closure between April 1 and August 31 during nesting season. Second, the trail could be reconfigured here so that it falls outside the one quarter mile buffer zone. Finally, the osprey platform could be relocated. If the City opts to move the platform, this should be done outside of nesting season if occupied. It should be noted that the actual osprey nest material may not be moved without a permit from the USFWS under the regulations of the MBTA. The nest material may be dismantled outside nesting season without penalty and material left for the osprey pair to collect and rebuild the nest at a new platform location.

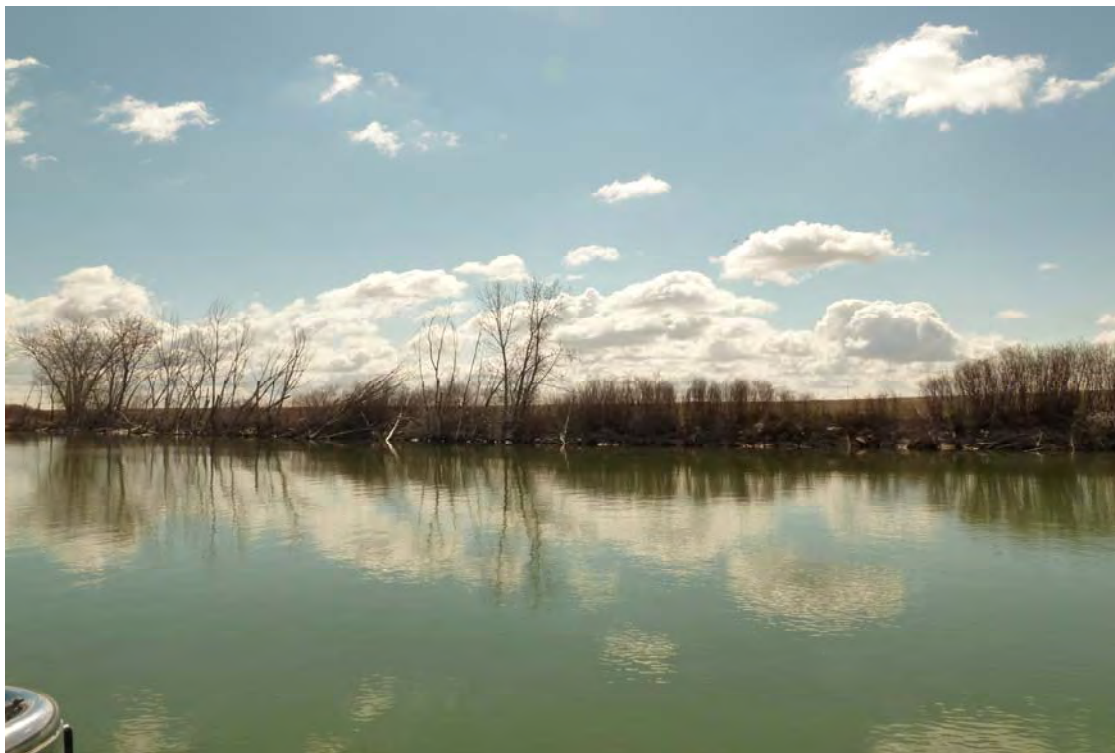
Along much of the eastern shoreline herbaceous wetland vegetation is well established and serves as a buffer between the open water and the adjacent City-owned agricultural fields. North of the osprey platform, the shoreline consists of a sandbar willow shrub layer, deadfall, herbaceous wetland vegetation including cattails and bulrushes, and rip rap. The structure, shade, and insects associated with this vegetation provide good aquatic and marsh habitat for wildlife as well as a good area for fishing (Photo 10).

Photo 10. May 2, 2011. Looking east at shoreline with good vertical and horizontal vegetation structure and agricultural land in the background. The native wetland vegetation, shade, and insects provide wildlife habitat and a good area for fishing.

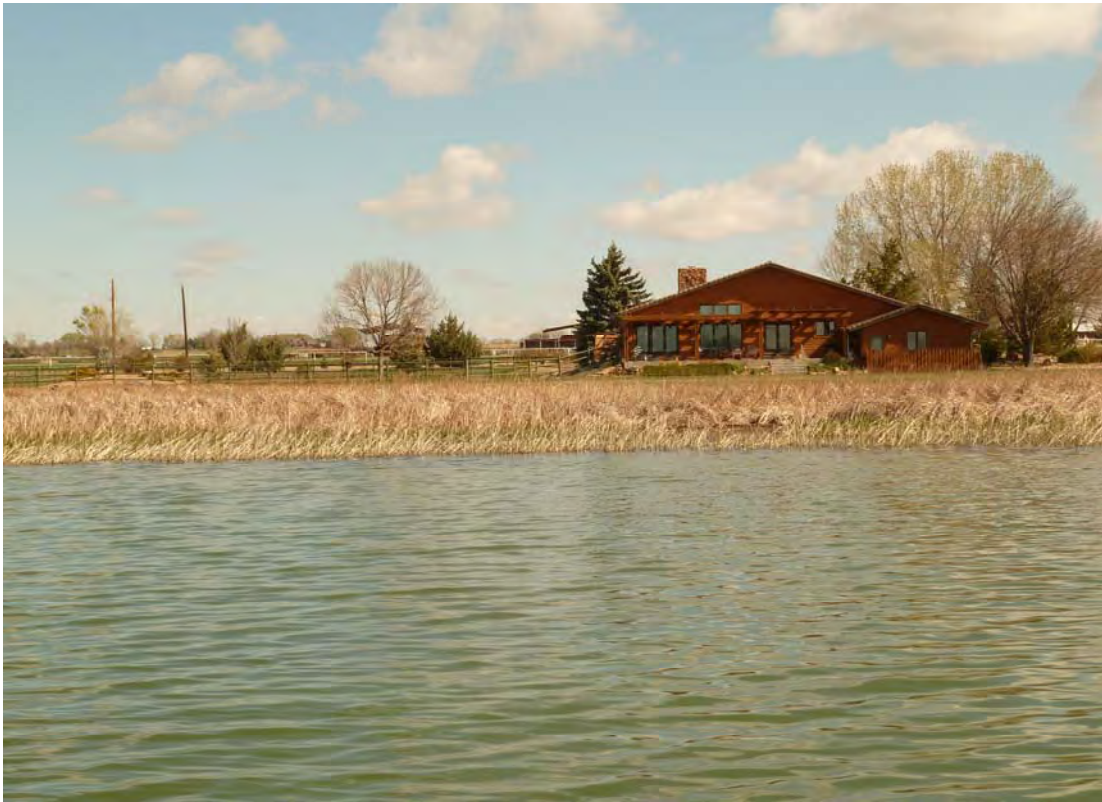
The northern shoreline is a mix of privately-owned and City-owned parcels. These parcels are mostly agricultural fields, former agricultural fields, or residential backyards. Between the reservoir's high and low watermarks, the northern shoreline (between the Unnamed Tributary and the Docheff Dairy) and northeast shoreline (near the Welsch and Walter properties) supports a wide swath of wetland vegetation extending away from the open water toward residential backyards along its shoreline and agriculture parcels on adjacent land (Photo 11). These cattails and bulrushes are intermittent. In some places through here, agriculture and residential land use extends directly to the edge of the reservoir. In these areas, a wetland vegetation buffer is absent and wave action with resulting erosion is apparent along the shoreline (Photo 12).

Photo 11. May 2, 2011. Looking north an a wide swath of wetland vegetation adjacent to a residential backyard.

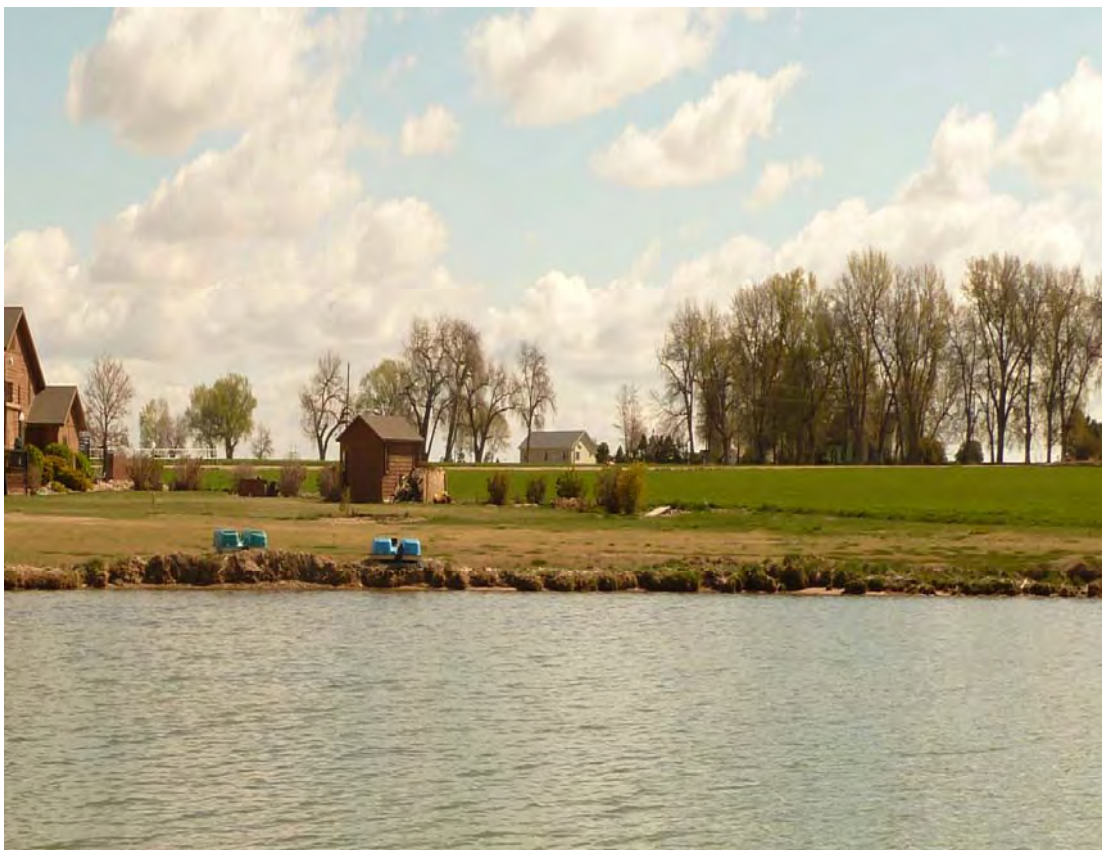
Photo 12. May 2, 2011. Looking north, northeast at wave action and resulting erosion along northern shoreline. Here there is no wetland vegetation edge to buffer the shoreline.

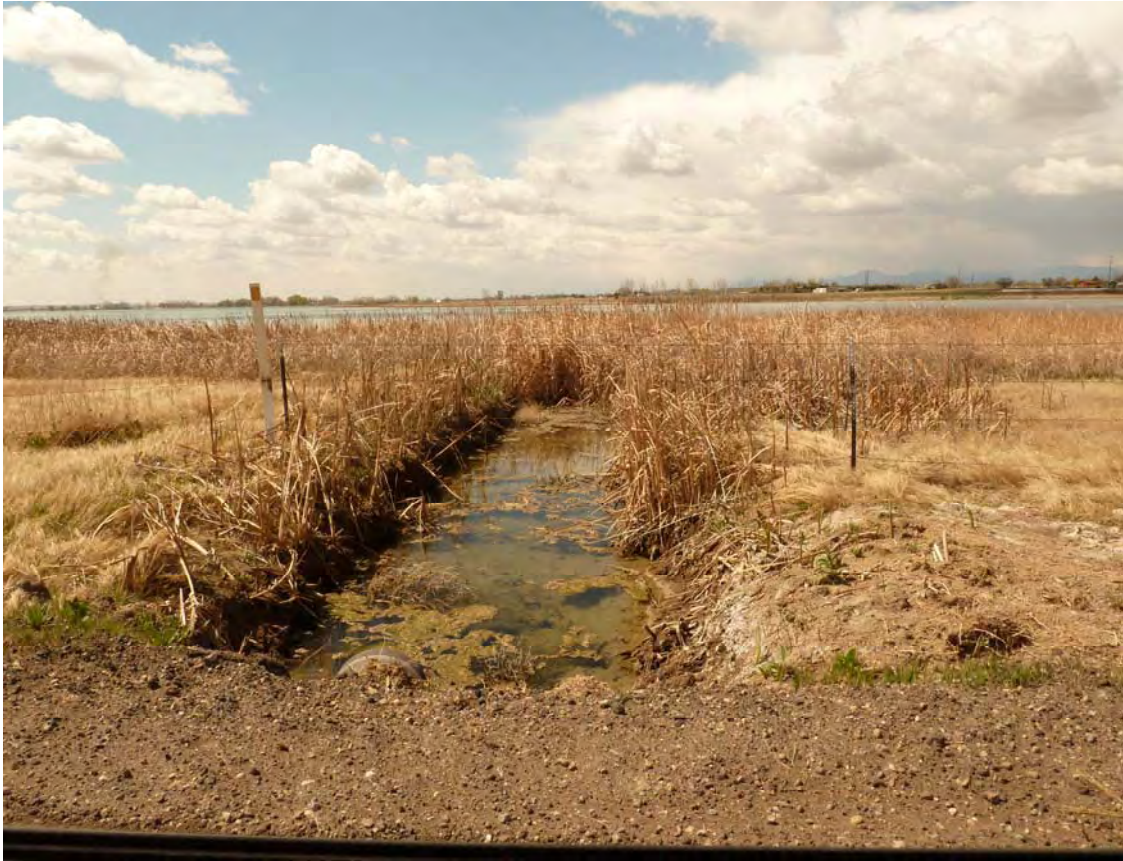
Wetland 4 was identified along the north shoreline, south of Weld County Road 28. This small wetland scrape supports cattails and other herbaceous wetland vegetation (Photo 13) and appears to have a surface connection to Union Reservoir and may receive sustaining hydrology via a pipe under the road, as well as road surface runoff.

Photo 13. May 2, 2011. Looking south at a Wetland 4. This small scrape is located south of Weld County Road 28. This scrape supports cattails and other herbaceous wetland vegetation and appears to have a surface connection to Union Reservoir. It may receive sustaining hydrology via a pipe under the road, as well as road surface runoff.

Because it has wetland vegetation and appears to have a surface connection to Union Reservoir, it would need to be verified by USACE to determine jurisdiction before disturbing the site.
