COLORADO CULTURAL RESOURCE SURVEY

Architectural Inventory Form

- 1. Resource number: **5BL.4928** Parcel number(s): **131503313003**
- 2. Temporary resource number: **N/A**
- 3. County: **Boulder**
- 4. City: **Longmont**
- 5. Historic Building Name: **Craig-Baker Inc. Building; Harvey-Shryack Motors Building; Longmont Motor Co. Building**
- 6. Current Building Name: **St. Vrain Glass and Upholstery Building**
- 7. Building Address: **635 3rd Avenue**
- 8. Owner Name: **635 LLC**
- Owner Organization:
- Owner Address: **202 Main Street, Suite 4
Longmont , CO 80501**

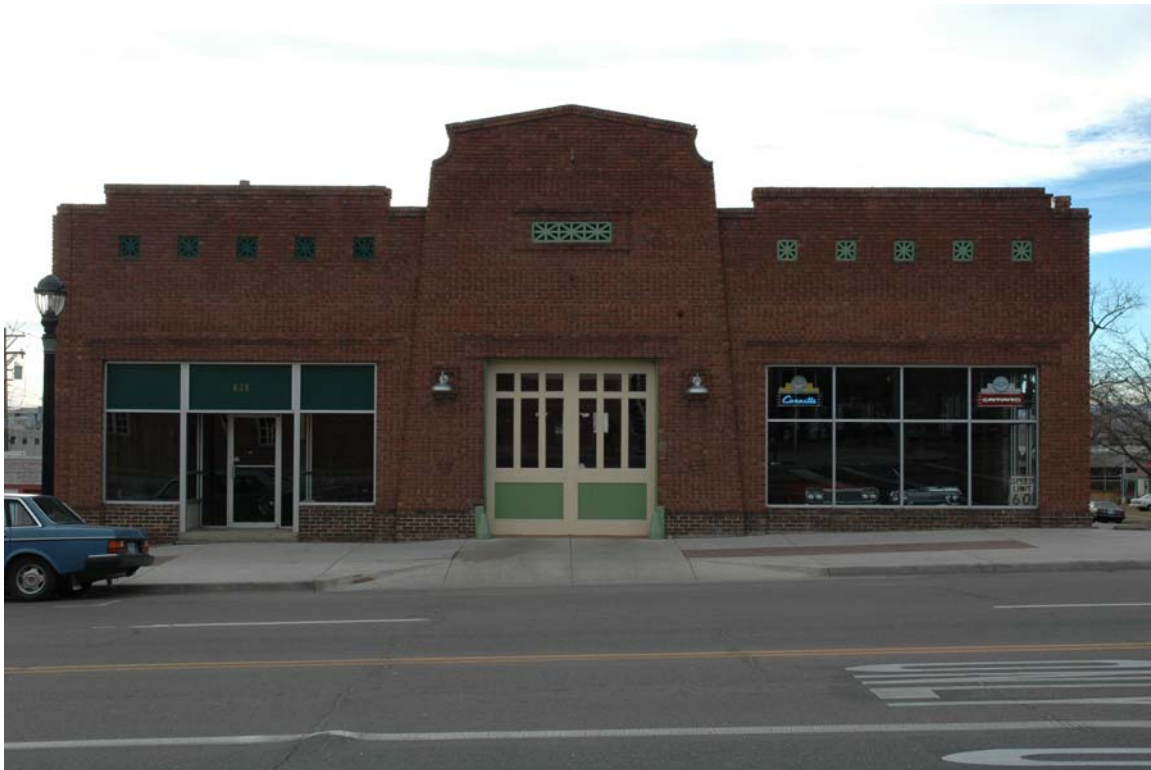
This former automobile dealership building measures 110' N-S by 60' E-W. Located at the southeast corner of 3rd Avenue and Coffman Street, the building's façade fronts directly onto the wide concrete sidewalk which parallels 3rd Avenue on the north elevation. The building is one story in height; however, there is a walk-out basement level on the south (rear) elevation. This is made possible because the ground slopes downward from the northwest to the southeast. The foundation walls are concrete, while the main walls are made of red bricks laid in common bond. A sign painted on the brick at the north end of the east elevation advertises the building's former business " St. Vrain Glass and Upholstering." The roof is flat, or nearly so, with stepped brick walls along the east and west elevations. The façade is symmetrical, with a tall false-front shaped gable in the center, flanked on either side by lower, flat, brick parapets. A distinctive painted green and white wood-paneled garage door, with vertically-oriented lights, is counter balanced, and when opened, the door rises into the space above. A band of four metal-framed storefront display windows penetrates the west half of the façade. A recessed entryway, with a glass-in-metal-frame door, with flanking sidelights and storefront display windows, penetrates the east half of the façade wall. Additional display windows penetrate the north end of the west elevation, facing toward Coffman Street. The west elevation is also penetrated by five sets of paired 2-light fixed-pane windows, and by a solid wood door which opens onto a small 6-step concrete dock. Four bands of 3-light basement-level windows penetrate the foundation wall along the west elevation as well. A large wood-paneled roll-away garage door enters the basement level on the south elevation, A band of four fixed-pane windows penetrates the main level on the south elevation, while sets of tripled and paired windows penetrate the basement level.
