COLORADO CULTURAL RESOURCE SURVEY

Architectural Inventory Form

- 1. Resource number: **5BL.10228** Parcel number(s): **131503233002**
- 2. Temporary resource number: **N/A**
- 3. County: **Boulder**
- 4. City: **Longmont**
- 5. Historic Building Name: **Miller House**
- 6. Current Building Name: **Weiss House**
- 7. Building Address: **817 Longs Peak Avenue**
- 8. Owner Name: **Weiss, John A**
- Owner Organization:
- Owner Address: **817 Longs Peak Ave**
Longmont , CO 80501

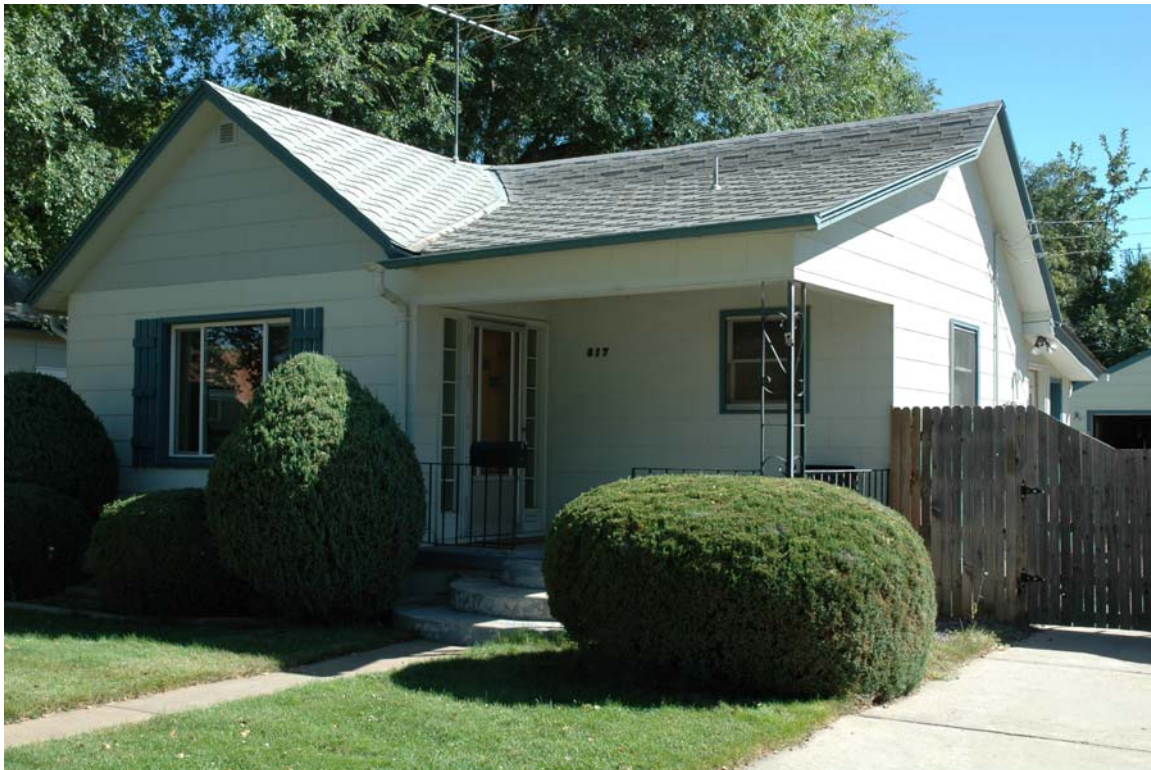
21. General architectural description:
The dwelling at 817 Longs Peak Avenue consists of the original T-shaped dwelling which was moved to this location in 1954, along with a 16' by 16' gabled addition which was built onto the south (rear) elevation in 1961. The main (east) wing of the original house measures 34' N-S by 16' E-W; the smaller (west) wing measures 21' N-S by 12' E-W. The leg of the "T" is filled in by an open 7' by 12' shed-roofed front porch which comprises the west end of the north elevation (façade). The house is supported by a low painted white concrete block foundation, and the exterior walls are clad with white asphalt shingle siding over wood frame construction. The roof features moderately-pitched intersecting gables, with grey asphalt composition shingles, and with boxed eaves with painted blue and white wood trim. There are no chimneys.

- A single-light fixed-pane window, flanked on either side by a narrow single-light horizontal sliding window, penetrates the façade wall, to the east of the entry porch. Otherwise, the home's windows are primarily single 1/1 and 2/2 double-hung sash, with painted white wood frames and painted blue wood surrounds. A stained natural brown solid wood door enters into the house from the shed-roofed front porch. The door has three stepped upper sash lights, is covered by a storm door, and is flanked by a row of glass block side lights. The front porch is approached by three rounded steps, and features a concrete floor, a black wrought iron railing, and black wrought iron posts which support the shed porch roof. A painted white wood-paneled door, with one upper sash light, enters into the dwelling at the south end of the west elevation where there is a small shed-roofed extension.**
