COLORADO CULTURAL RESOURCE SURVEY

Architectural Inventory Form

- 1. Resource number: **5BL.10162** Parcel number(s): **131503219007**
- 2. Temporary resource number: **N/A**
- 3. County: **Boulder**
- 4. City: **Longmont**
- 5. Historic Building Name: **Dworak House; Jones House**
- 6. Current Building Name: **Knight House**
- 7. Building Address: **526 Pratt Street**
- 8. Owner Name: **Knight, Joe W & Doris**
- Owner Organization:
- Owner Address: **535 Pratt St**
Longmont , CO 80501

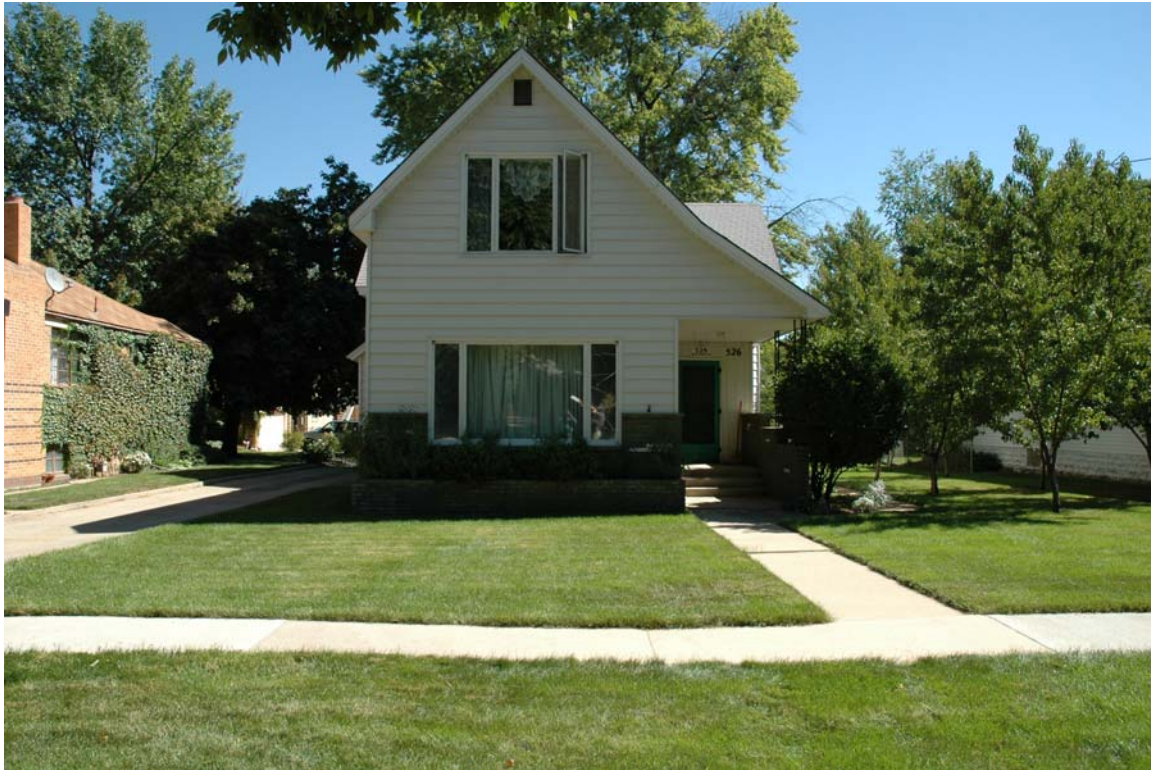
21. General architectural description:
The residence at 526/528 Pratt Street is composed of a gable-on-hip roofed wood frame dwelling, which was built originally in 1901-1902, and a 16' N-S by 14' E-W 1.5 story gabled addition which was built onto the west elevation (façade) in 1960. Overall, the building measures 28' N-S (across) by ~64' E-W (deep). Built initially as a single family home, the dwelling was converted into an over/under duplex in the early 1970s. The original building is supported by an unpainted coursed sandstone foundation, which is penetrated at intervals by single-light hopper basement windows. The exterior walls are clad with white horizontal vinyl siding, and the gable and hip roof forms are covered with grey asphalt shingles. The eaves are boxed. A large non-historic shed-roofed dormer, with a single-light fixed-pane window flanked by two single-light casement windows, is located on the south-facing roof slope. A historic gabled wall dormer is located on the east (rear) elevation. This dormer has been modified by the insertion of a wood-paneled entry door which provides access into the upper half story from the top of a long wooden staircase on the east elevation. Twin red brick chimneys, with corbelled caps, are located on the historic west-facing roof slope.

A canted bay, with three 1/1 double-hung sash windows, is located beneath an intersecting gable on the south elevation. A single-light fixed-pane picture window penetrates the west (façade) elevation wall of the 1960 addition. Elsewhere, the building's original windows are primarily single 1/1 double-hung sash, with painted white wood frames and surrounds. The house historically featured a screened-in wraparound porch, which
