COLORADO CULTURAL RESOURCE SURVEY

Architectural Inventory Form

- 1. Resource number: **5BL.1237** Parcel number(s): **131503314003**
- 2. Temporary resource number: **N/A**
- 3. County: **Boulder**
- 4. City: **Longmont**
- 5. Historic Building Name: **Pearson House; Taft House; Matthews House**
- 6. Current Building Name: **Murdoch Mara Properties House**
- 7. Building Address: **713 3rd Avenue**
- 8. Owner Name: **Murdoch Mara Properties LLC**
- Owner Organization:
- Owner Address: **713 3rd Ave**
Longmont , CO 80501

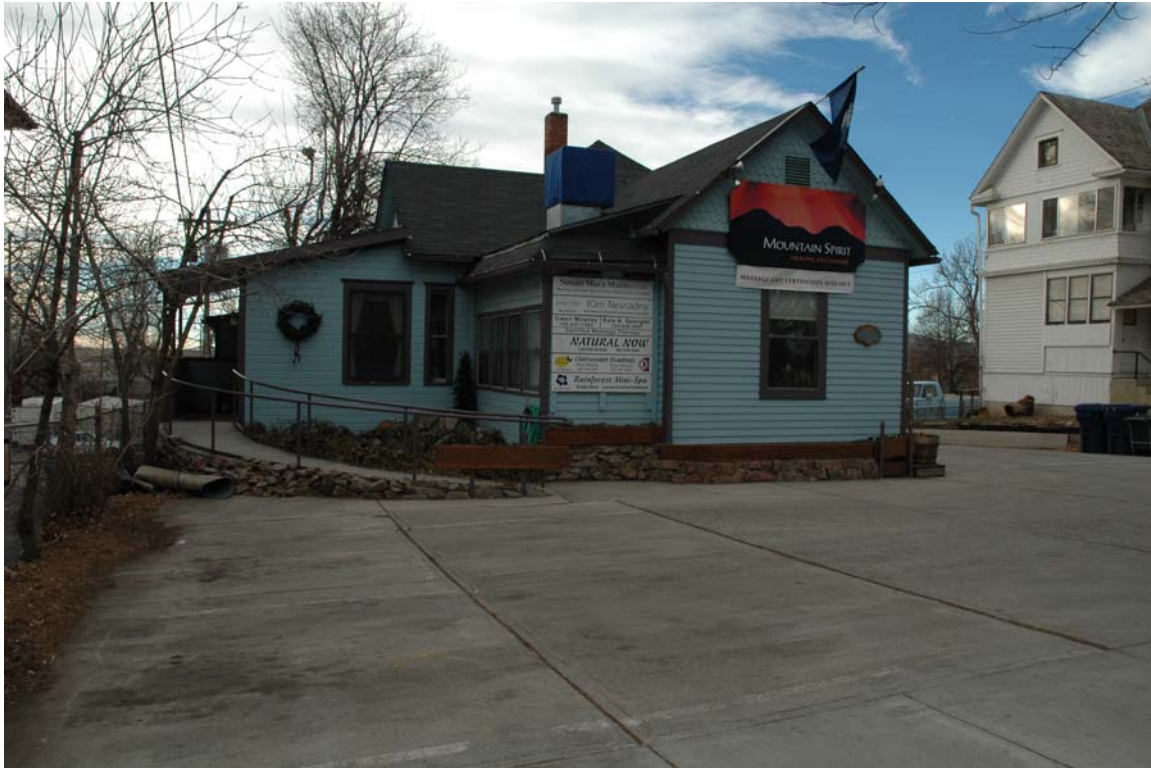
21. General architectural description:
This former single family dwelling is located on the south side of 3rd Avenue in the block between Coffman and Terry Streets. It is a single story wood frame building supported by a low coursed sandstone foundation. The exterior walls are primarily clad with painted pale blue horizontal wood siding, with painted pale purple 1" by 4" corner boards; however, in some areas the walls are clad with horizontal weatherboard siding, and there are octagon patterned wood shingles in the upper gable ends on the north and east elevations. The gable-on-hip roof is moderately pitched, and is covered with black asphalt composition shingles. The eaves are boxed, with painted pale blue wood trim, and there is a red brick chimney located just below the ridge on the east-facing roof slope. The home's windows are primarily 1/1 double-hung sash, with painted wood frames and surrounds. However, there are some non-historic 1x1 horizontal sliding windows. A non-historic wood-paneled door, with a transom light, and with a white synthetic storm door, leads into the building from a 2-step wood stoop at the north end of the west elevation. Another paneled door leads into the building from a shed-roofed porch on the east elevation. This porch is approached by a non-historic concrete handicapped-accessible ramp with a pipe railing.

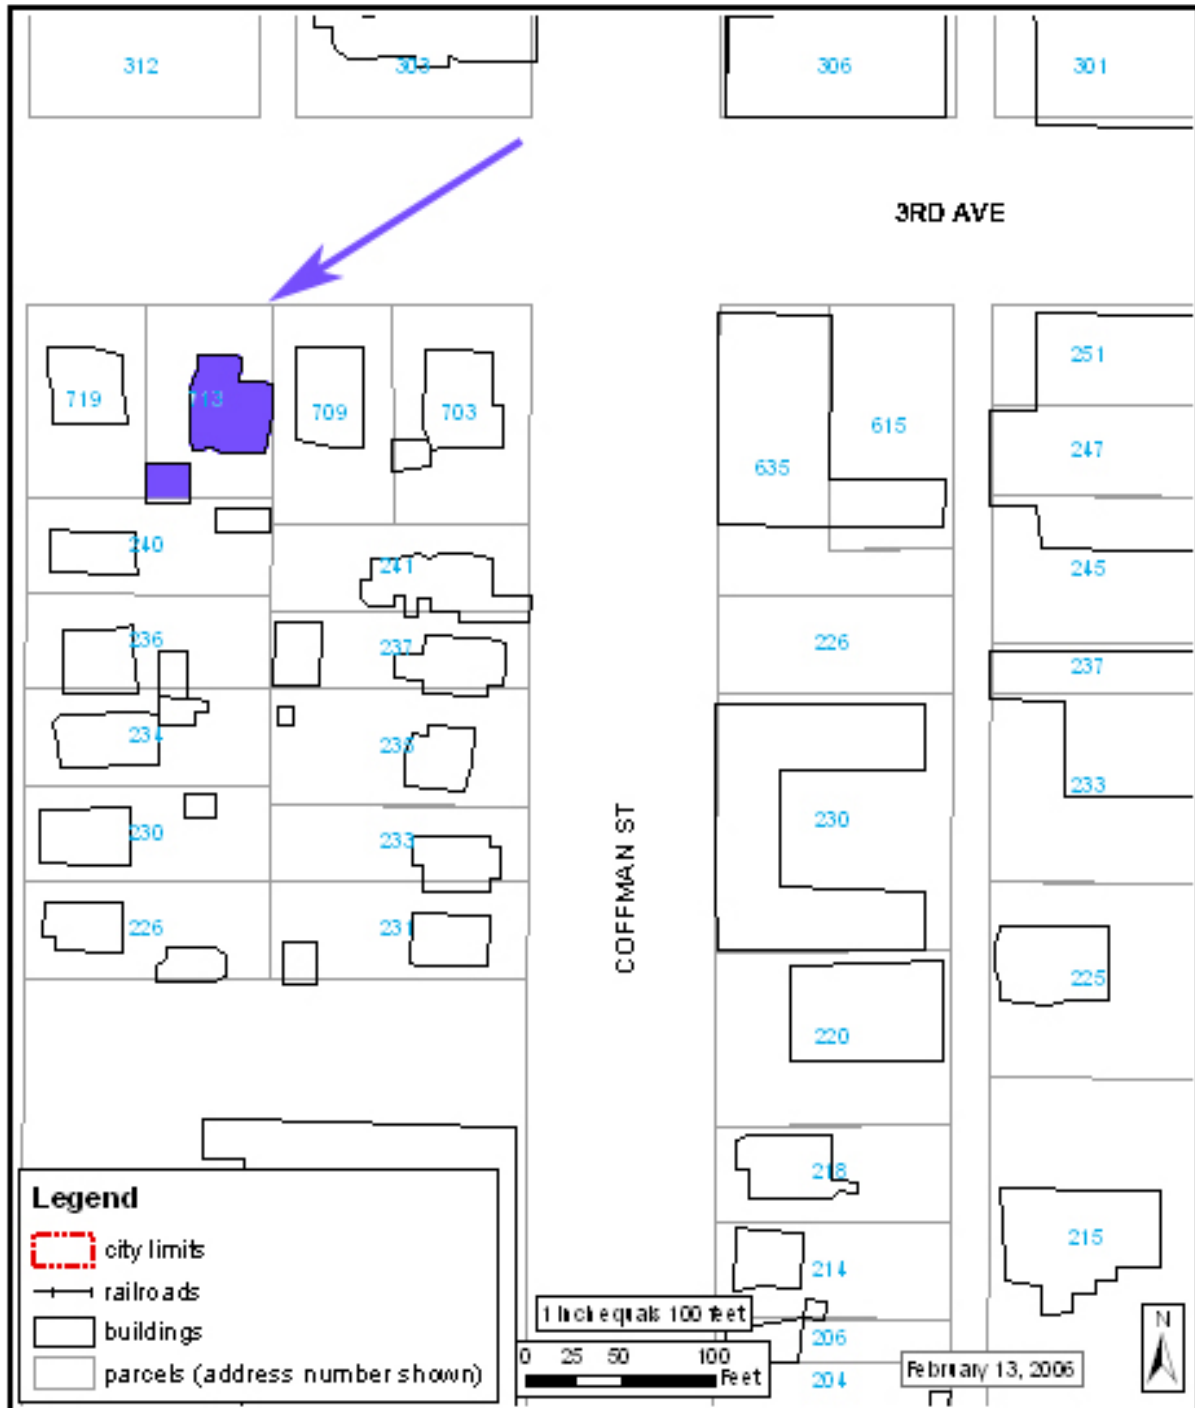
Sketch Map

23. Landscape or special setting features: **This property is located on the south side of 3rd Avenue near the south end of Longmont's historic West Side Neighborhood. Concrete parking areas are located in front of the building to the north, and beside the building to the west.**
