COLORADO CULTURAL RESOURCE SURVEY

Architectural Inventory Form

- 1. Resource number: **5BL.7351** Parcel number(s): **131503114014**
- 2. Temporary resource number: **N/A**
- 3. County: **Boulder**
- 4. City: **Longmont**
- 5. Historic Building Name: **Schulz House; Zahn House; Luedeman House**
- 6. Current Building Name: **Moore House**
- 7. Building Address: **8 6th Avenue**
- 8. Owner Name: **Colin P. Moore**
- Owner Organization:
- Owner Address: **8 6th Ave**
Longmont , CO 80501

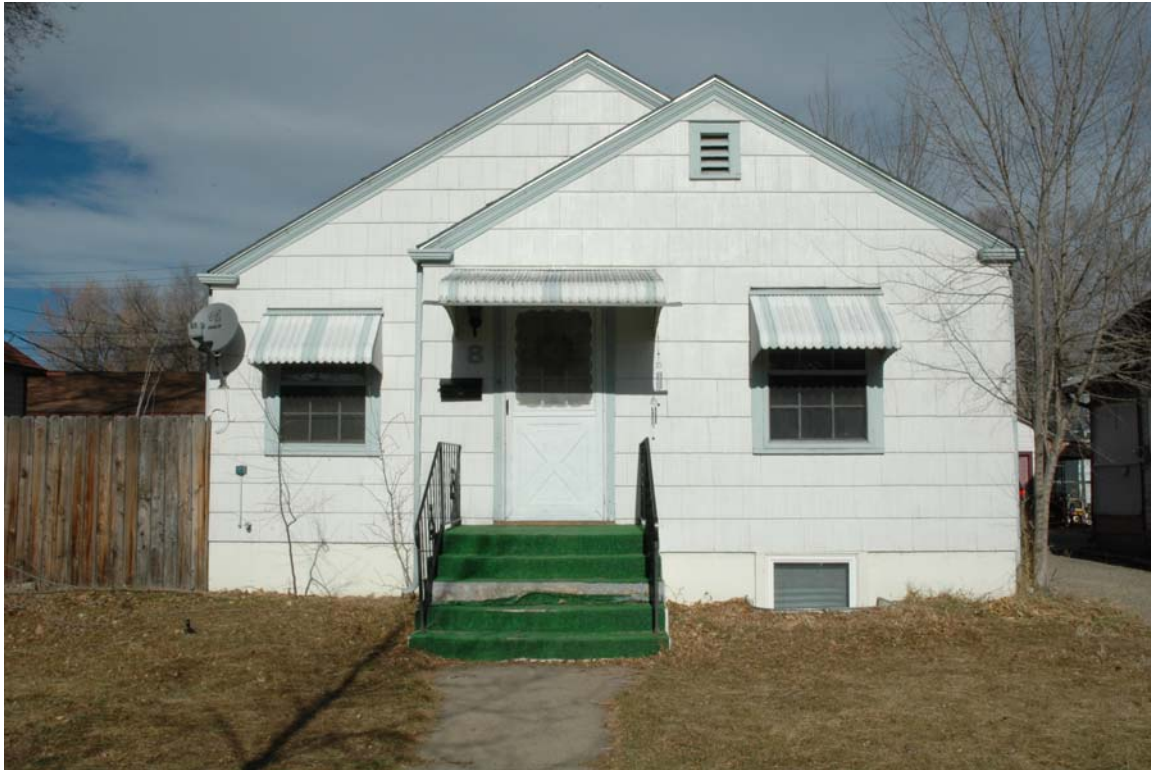
21. General architectural description:
Built in 1946, the modest wood frame dwelling at 8 6th Avenue measures 32' N-S (deep) by 26' E-W (across). These dimensions, though, do not include a small shed-roofed rear porch extension on the north elevation. The house is supported by a low painted white concrete foundation, and its exterior walls are clad with white asphalt shingle siding. There appears to be a full basement beneath the main level. The front gabled roof is moderately-pitched, with asphalt composition shingles, and the eaves are closed. A red brick chimney is located on the east-facing roof slope. Two 6/6 double-hung sash windows, with painted wood frames and surrounds, and with metal awnings, penetrate the façade wall. Windows elsewhere on the dwelling are primarily 4/1 (ribbon style) double-hung sash, and 1/1 double-hung sash, with painted wood frames and surrounds. The front entry door, covered by a white metal storm door, leads into the house from a 5-step carpeted concrete porch on the south elevation. The porch is covered by a metal awning, and is flanked by black wrought iron railings. A glass-in-wood-frame rear entry door leads into the small shed-roofed extension from a 5-step wood stoop on the north elevation. A 6/6 double-hung sash window penetrates the extension on the north elevation.
