COLORADO CULTURAL RESOURCE SURVEY

Architectural Inventory Form

- 1. Resource number: **5BL.10125** Parcel number(s): **131503410005**
- 2. Temporary resource number: **N/A**
- 3. County: **Boulder**
- 4. City: **Longmont**
- 5. Historic Building Name: **Finlon House**
- 6. Current Building Name: **Campbell House**
- 7. Building Address: **338 Collyer Street**
- 8. Owner Name: **Campbell, Gordon L & Judy J**
- Owner Organization:
- Owner Address: **338 Collyer St**
Longmont , CO 80501

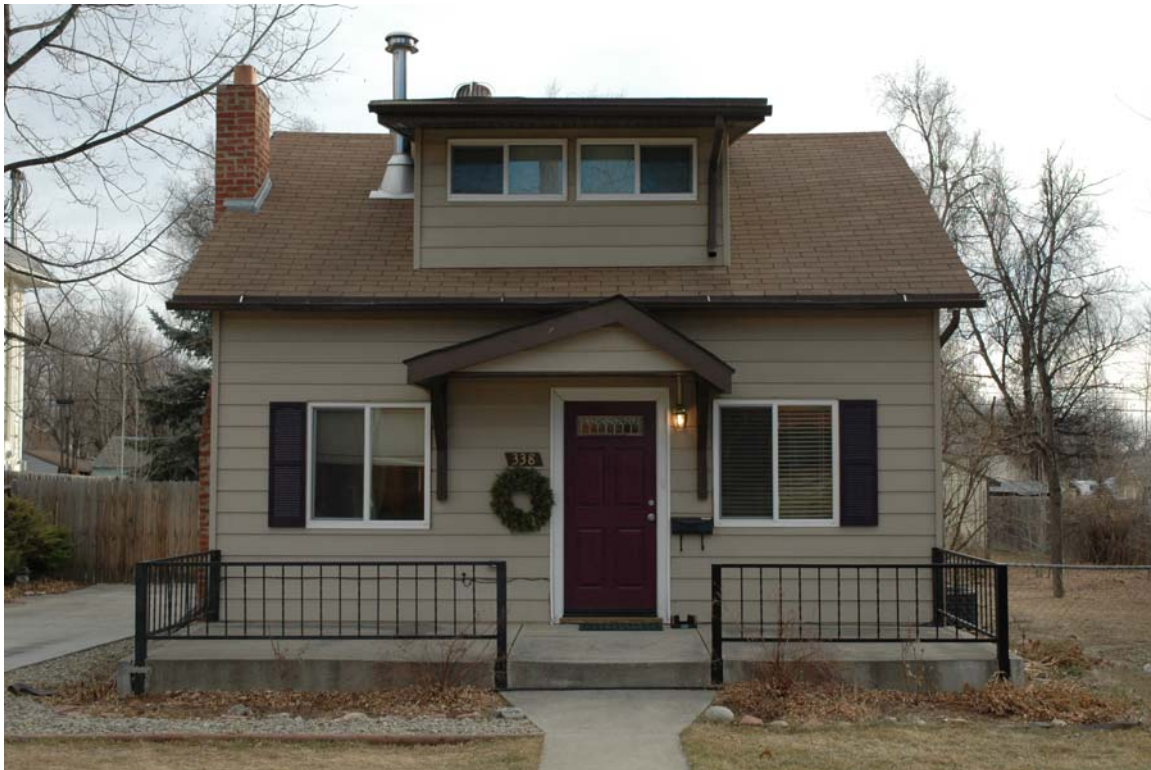
21. General architectural description:
The house at 338 Collyer Street is a 1.5 story wood-frame dwelling, which measures 22' N-S (across) by 24' E-W (deep), with a shed-roofed extension to the east (rear) elevation. The house is supported by a low coursed sandstone foundation, and its exterior walls are clad with wide, beige color, horizontal aluminum siding. The side-gabled roof is moderately-pitched, and is covered with brown asphalt composition shingles. The eaves are boxed with painted brown wood trim. A shed-roofed dormer, with two non-historic 1x1 horizontal sliding windows, overlooks the façade on the west-facing roof slope. Two non-historic bubble skylights are located on the east (rear) facing roof slope. A red brick fireplace chimney, which is also probably not historic, is located on the north elevation. Nearly all of the home's windows appear altered from their historic configuration. Two 1x1 horizontal sliding windows flank the front entry door on the nearly symmetrical façade. A 1/1 double-hung sash window is located in the upper gable end on the north elevation. One 1x1 horizontal sliding window is located in the upper gable end on the south elevation. Elsewhere, the windows are primarily 1x1 horizontal sliders with decorative shutters. A non-historic, painted maroon, wood-paneled front door, with one leaded glass upper sash light, enters the façade from a non-historic 22' by 7' concrete porch with a black wrought iron railing. The porch is for the most part uncovered; however, a saltbox hood with knee brace supports is situated over the entry. A painted white rear entry door leads into the east elevation from a small concrete porch.

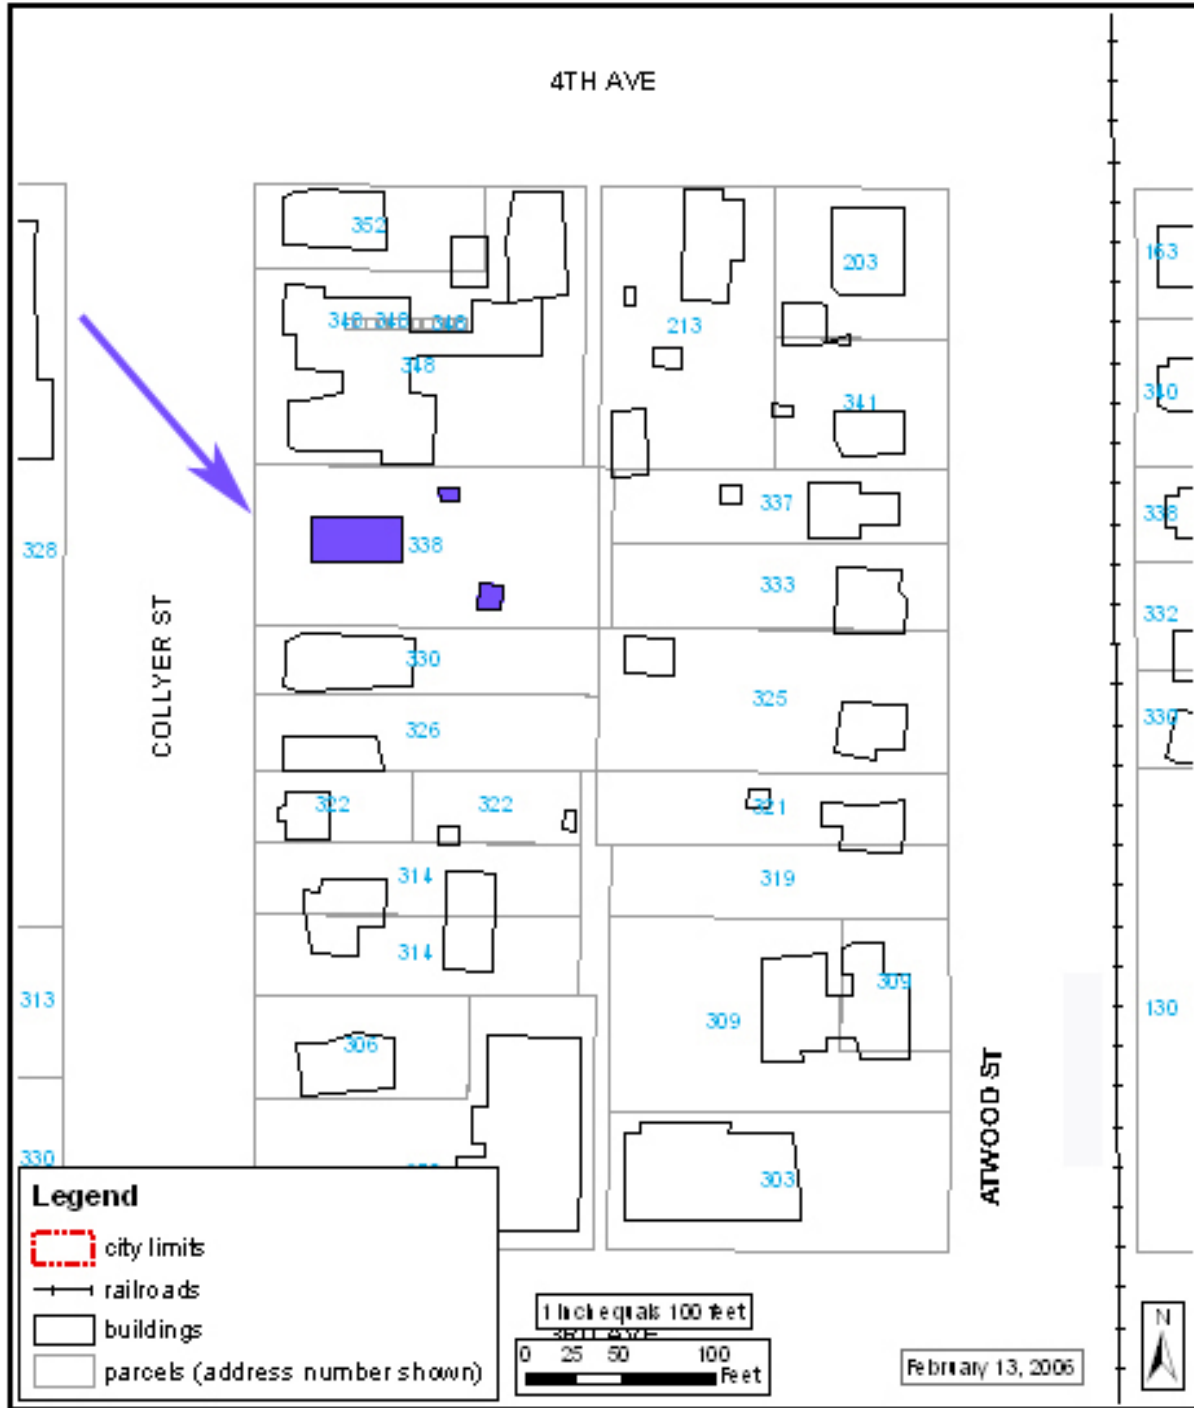
Sketch Map

23. Landscape or special setting features: **This property is located on the east side of Collyer Street, near the south end of Longmont's historic East Side residential neighborhood. The property features well cared-for front and back yards, as well as a wide side yard to the south of the house. A concrete driveway extends along the north side of the house.**

Describe: **A single-stall wood frame garage is located northeast of the house. This utilitarian structure features a concrete foundation, vertical composition board siding, and a low-pitched gable roof.**
